Client: Turning Point Project Management

Reference: 18-0975R01

This report presents the results of a geotechnical investigation for the proposed Diepkloof Empowerment Zone in Soweto, Gauteng Province, and presents the conclusions and recommendations for materials usage, excavations, foundations and earthworks.

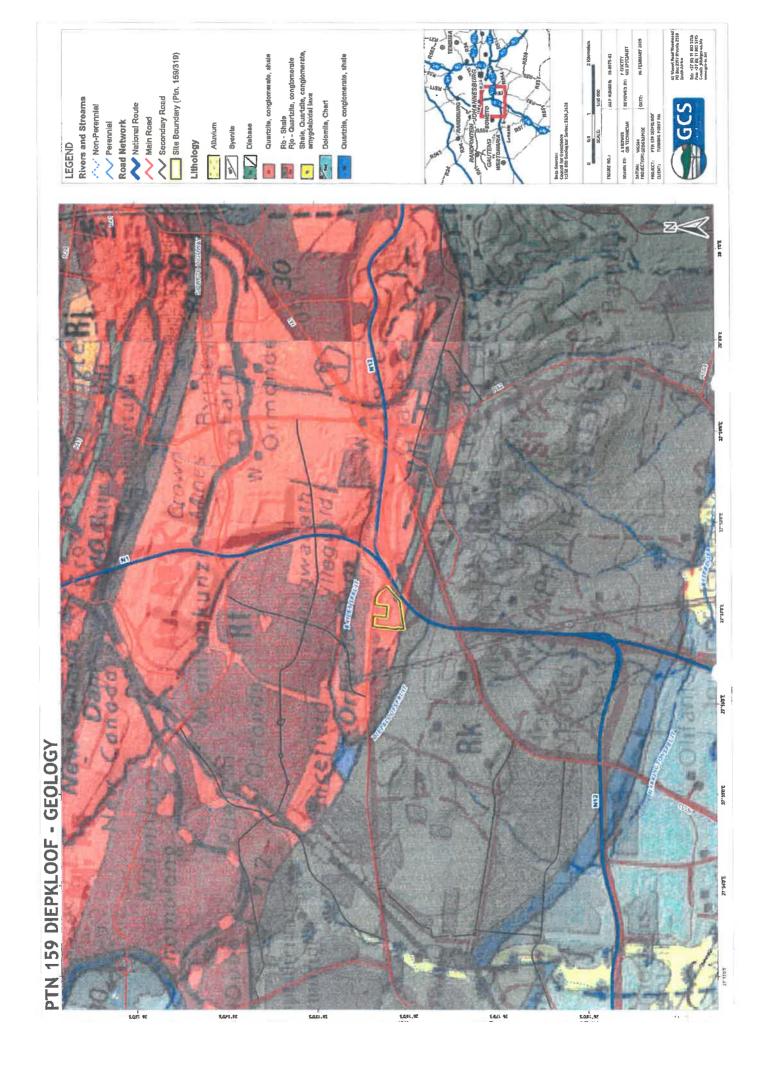
Figure 2 Geological Plan

At a regional scale, based on the 1:250 000 Geological Map titled "2626 West-Rand (1986)", the site can be seen to be underlain by quartzite, conglomerate and shale of the Turffontein Subgroup, Central Rand Group of the Witwatersrand Supergroup.

Based on the 1:250 000 Geological Map titled "2626 West-Rand (1986)", the site can be seen to be underlain by quartzite, conglomerate and shale of the Turffontein Subgroup, Central Rand Group of the Witwatersrand Supergroup.
